RE: Rock Lake Fish Hatchery NMDG&F; Minor Industrial; NPDES Compliance Evaluation Inspection; SIC 0921; NPDES NM0030155; January 17, 2019

NPDES Compliance Inspection Report

Rock Lake Fish Hatchery NMDG&F NPDES Permit NM0030155 Compliance Evaluation Inspection January 17, 2019

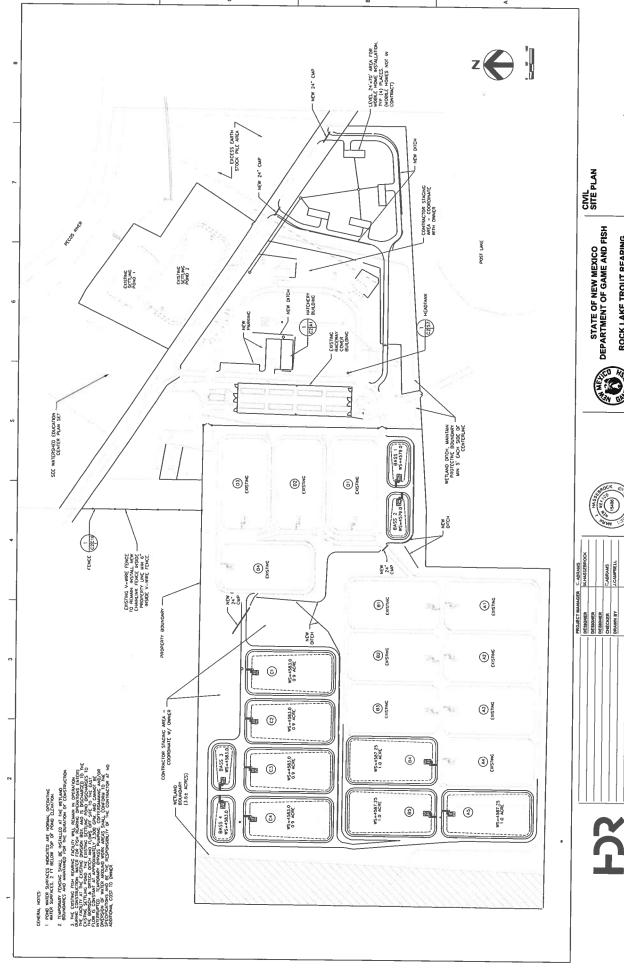
SHECT C2

CIVIL SITE PLAN

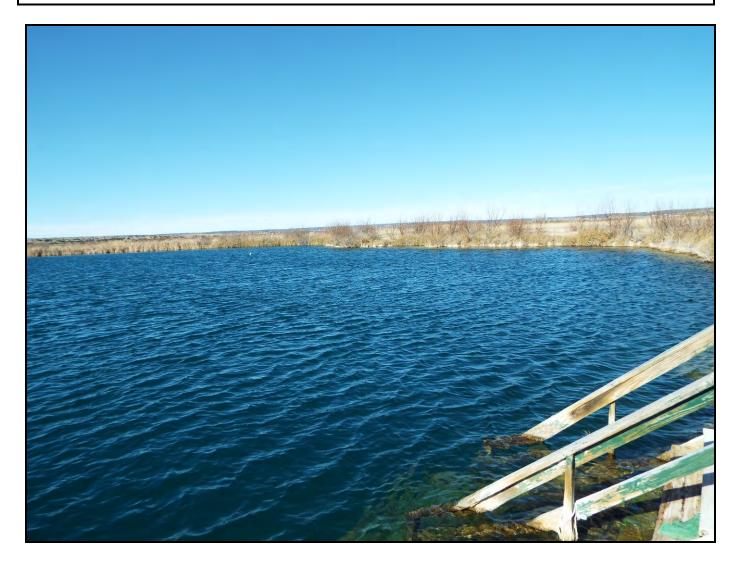
Photographer: Daniel Valenta	Date: 1/17/2019	Time: 1201 hours			
City/County: South of the city of Santa Rosa/Guadalupe County					
Location: Rock Lake Fish Hatchery at HRC 69 River Road Hatchery Loop.					
Subject: Rock Lake is the source v	rater for the hatchery.

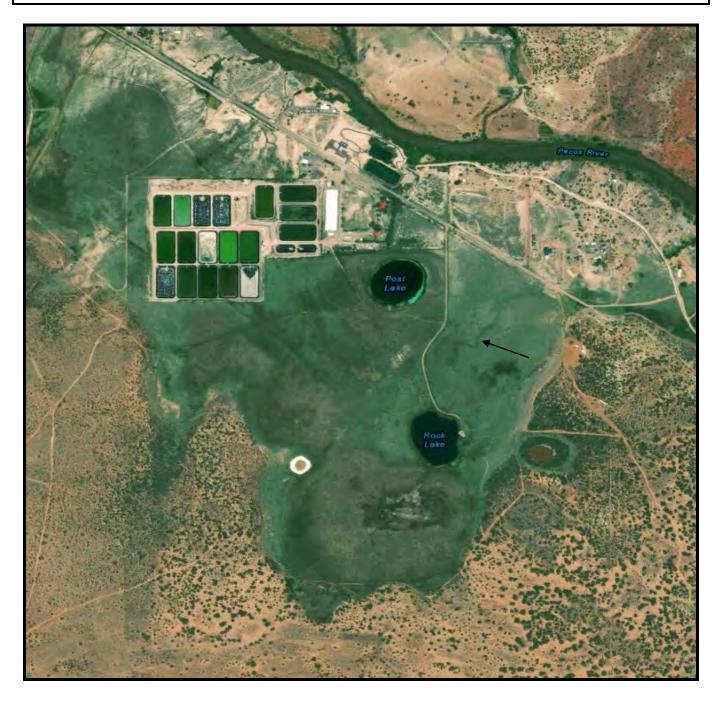
NMED/SWQB Overview of Area

Subject: Overview of Rock Lake Hatchery and Rock Lake. Before the hatchery the artesian spring would overflow into the surrounding green area. The arrow points to the natural drainage channel for the area.

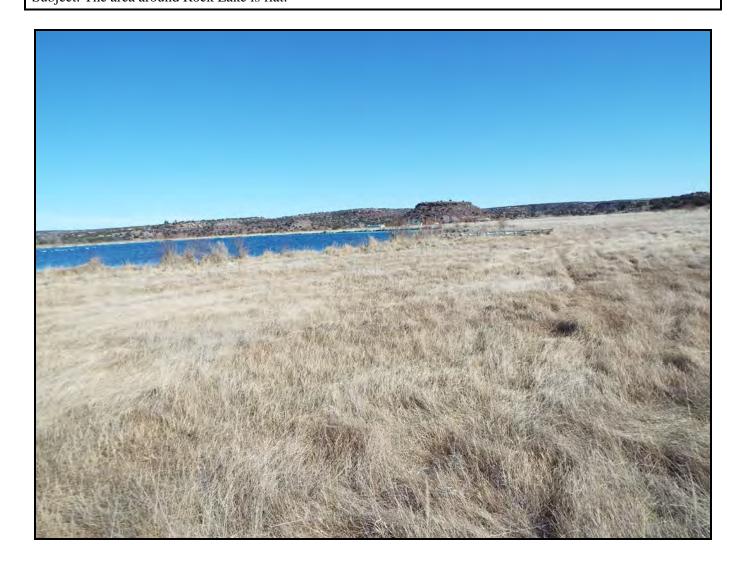
Photographer: Daniel Valenta	Date: 1/17/2019	Time: 1210 hours				
City/County: South of the city of Santa Rosa/Guadalupe County						
Location: Rock Lake Fish Hatchery at HRC 69 River Road Hatchery Loop.						
Subject: The area around Rock Lake	Subject: The area around Rock Lake is flat.

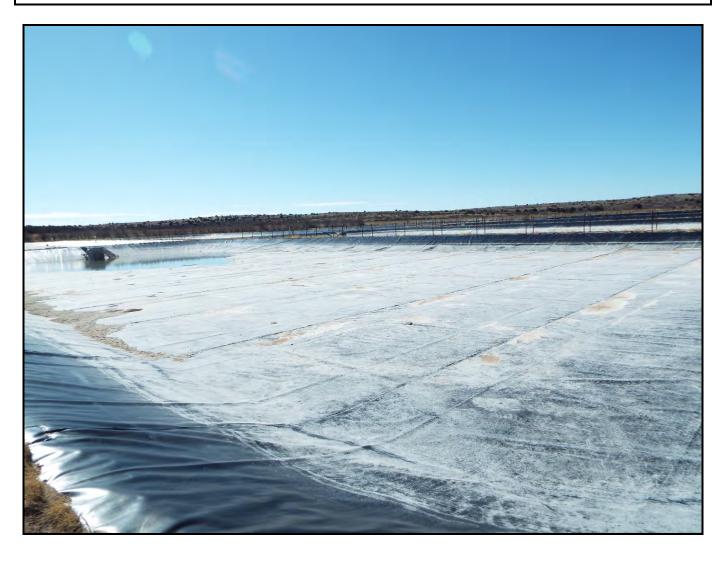
Photographer: Daniel Valenta	Date: 1/17/2019	Time: 1223 hours			
City/County: South of the city of Santa Rosa/Guadalupe County					
Location: Rock Lake Fish Hatchery at HRC 69 River Road Hatchery Loop.					
Subject: Lagoons are lined and only	y used seasonally.

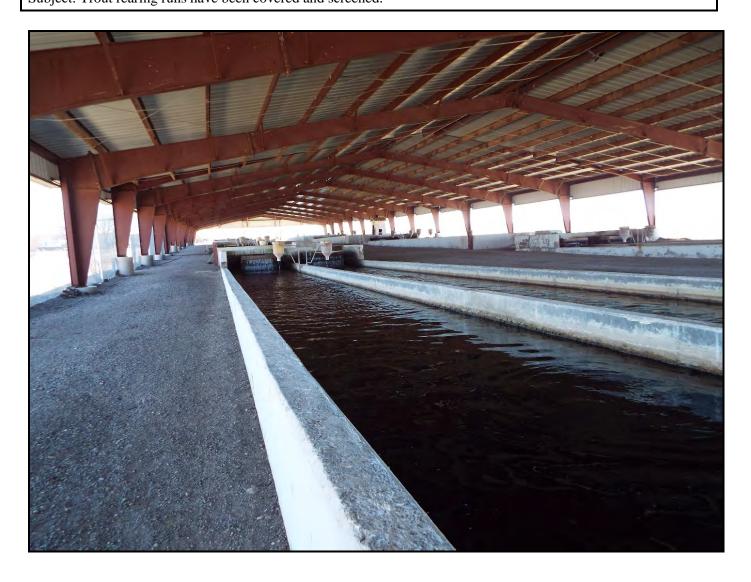
Photographer: Daniel Valenta	Date: 1/17/2019	Time: 1248 hours			
City/County: South of the city of Santa Rosa/Guadalupe County					
Location: Rock Lake Fish Hatchery at HRC 69 River Road Hatchery Loop.					
Subject: Trout rearing runs have been covered and screened

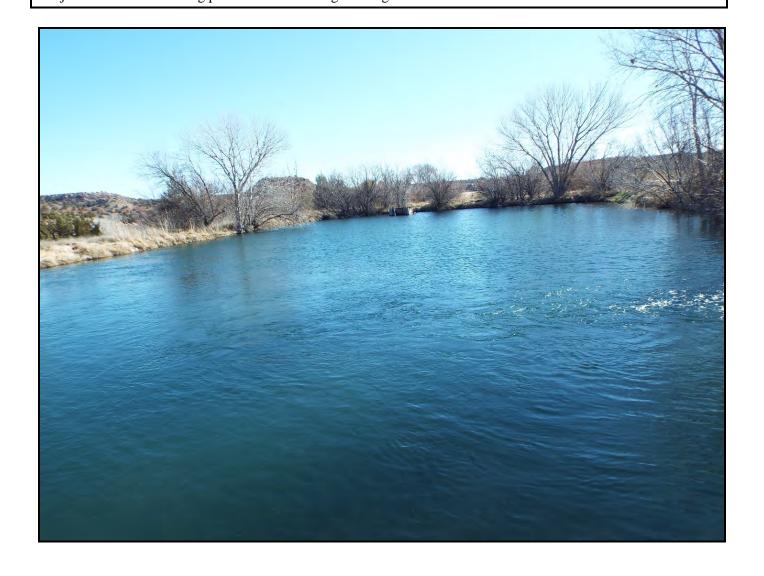
Photographer: Daniel Valenta	Date: 1/17/2019	Time: 1116 hours			
City/County: South of the city of Santa Rosa/Guadalupe County					
Location: Rock Lake Fish Hatchery at HRC 69 River Road Hatchery Loop.					
Subject: First of two settling ponds b	efore discharge to irrigation channel or the Pe	cos river.

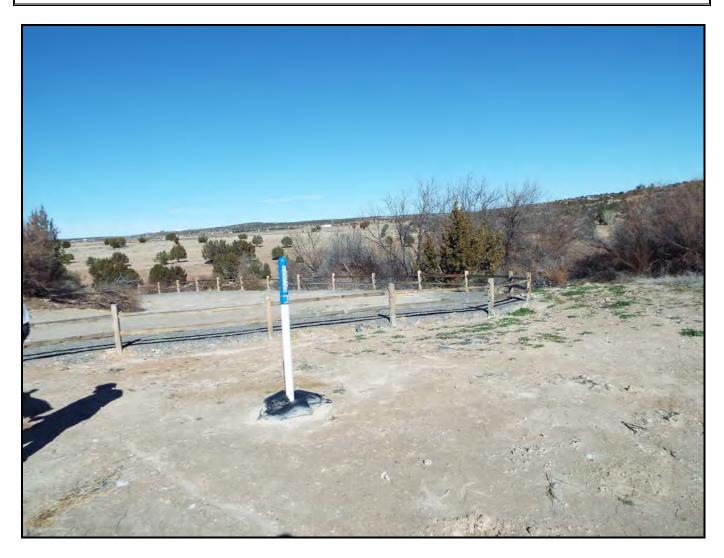
Photo # 6

Subject: A doppler meter is attached to the underground pipe that connects the settling pond to the Ortega-Borsich ditch or Pecos river. Flow can be measured at the white PVC pipe.

4. CALIBRATION FREQUENCY ADEQUATE. (Calibration records must be maintained for new flow meter if meter	r needs to be calibrated.) □ Y ⊠ N □ NA
RECORDS MAINTAINED OF CALIBRATION PROCEDURES. CALIBRATION CHECKS DONE TO ASSURE CONTINUED COMPLIANCE.	□ Y ⊠ N ⊠ NA □ Y ⊠ N ⊠ NA

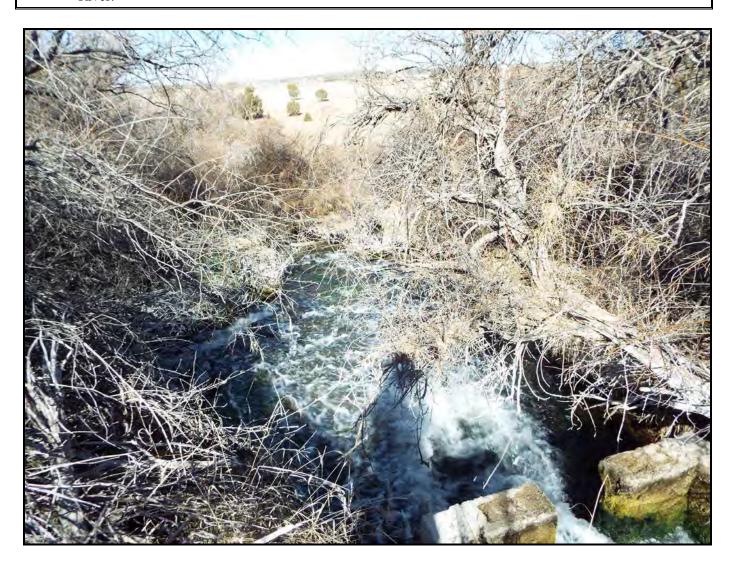
Photo #7

Subject: Water can be discharged to the Pecos river or into the Ortega-Borsich ditch. This discharge is to the Pecos River.

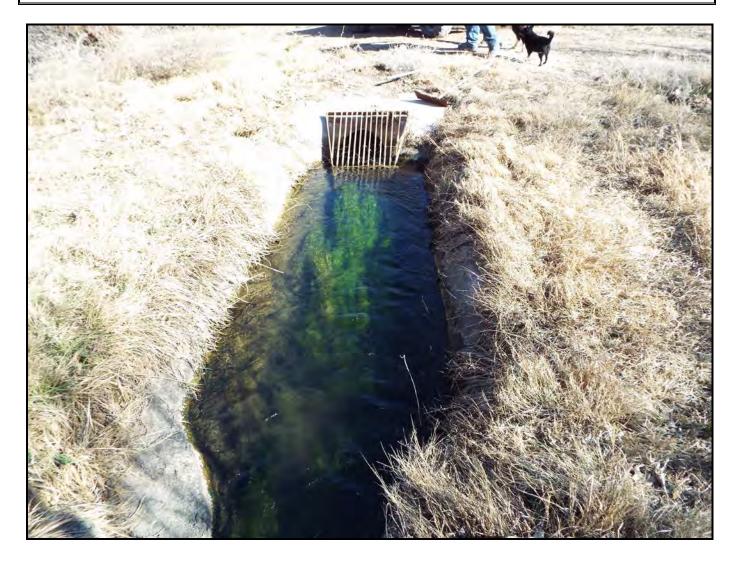
Photographer: Daniel Valenta	Date: 1/17/2019	Time: 1311 hours			
City/County: South of the city of Santa Rosa/Guadalupe County					
Location: Rock Lake Fish Hatchery at HRC 69 River Road Hatchery Loop.					
Subject: Water can be directed into	the Ortega-Borsich ditch for agriculture use.

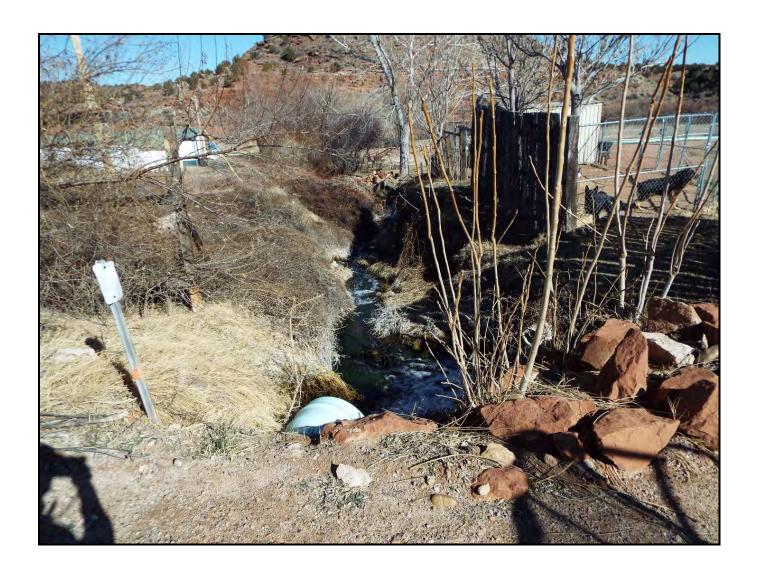
Photographer: Daniel Valenta	Date: 1/17/2019	Time: 1316 hours	
City/County: South of the city of Santa Rosa/Guadalupe County			
Location: Rock Lake Fish Hatchery at HRC 69 River Road Hatchery Loop.			
Subject: Discharge from the Ortega-Borsich ditch to the Pecos River.

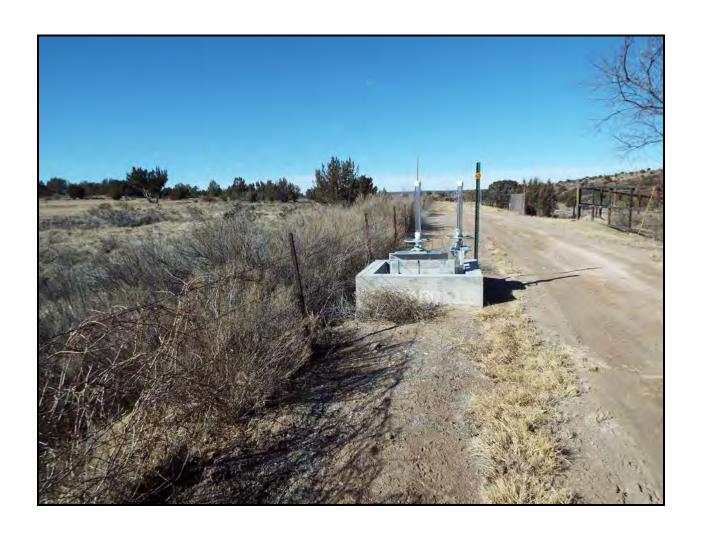
Photographer: Daniel Valenta	Date: 1/17/2019	Time: 1322 hours
City/County: South of the city of Santa Rosa/Guadalupe County		
Location: Rock Lake Fish Hatchery at HRC 69 River Road Hatchery Loop.		
Subject: Diversion point from the Ortega-Borsich ditch to the Pecos River.
